Service Bulletin

Bulletin No.: 21-NA-251

Subject: Information on Appearance Concern with Driver Outside Rearview Mirror Dimming

Brand:	Model:	Model Year:		VIN:		Engine:	Transmission:
		from	to	from	to		
Chevrolet	Corvette	2020	2022	—	—	All	All

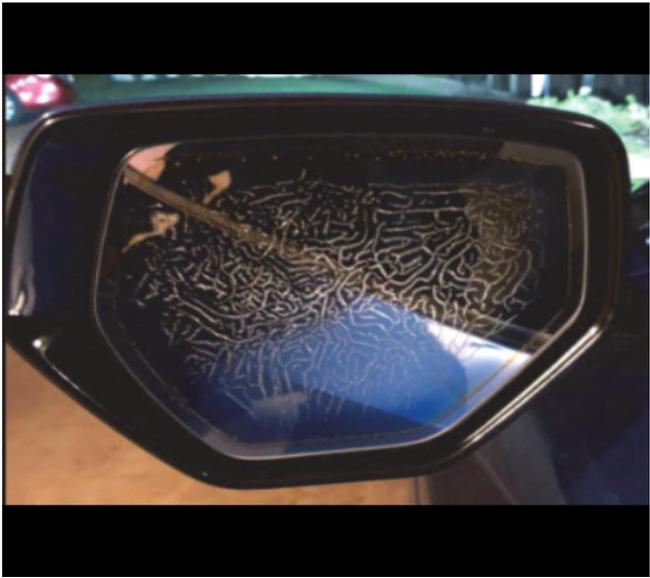
<p style="text-align: right; font-size: small;">5918432</p> <p>Some customers may comment that their driver outside rearview mirror has numerous lines in it and it looks dim all the time. The electrical device may cause higher voltage to the mirror.</p>
Cause	This condition may be caused by the installation of an aftermarket radar detector jumper harness that powers a radar detector.
Correction	<p>Note: If this Condition is found, it may be a customer pay repair and NOT a Warrantable repair.</p> <p>The technician should inspect for a jumper harness added to the mirror's X1 connector. The connector located behind the front cover of the inside rearview mirror.</p> <p>Authorization for disconnecting the jumper harness, and/or replacement of a damaged outside rearview mirror, must be obtained from the customer.</p>
